AERIAL SURVEY
HAZARDOUS MATERIALS DISPOSAL SITES
IOWA, KANSAS, MISSOURI
JULY-SEPTEMBER 1979

EMSL-LV PROJECT 7964

Lockheed Engineering and Management
Services Company, Inc.
Remote Sensing Laboratory
Las Vegas, Nevada 89114

OFFICE OF RESEARCH AND DEVELOPMENT
U.S. ENVIRONMENTAL PROTECTION AGENCY
LAS VEGAS, NEVADA 89114

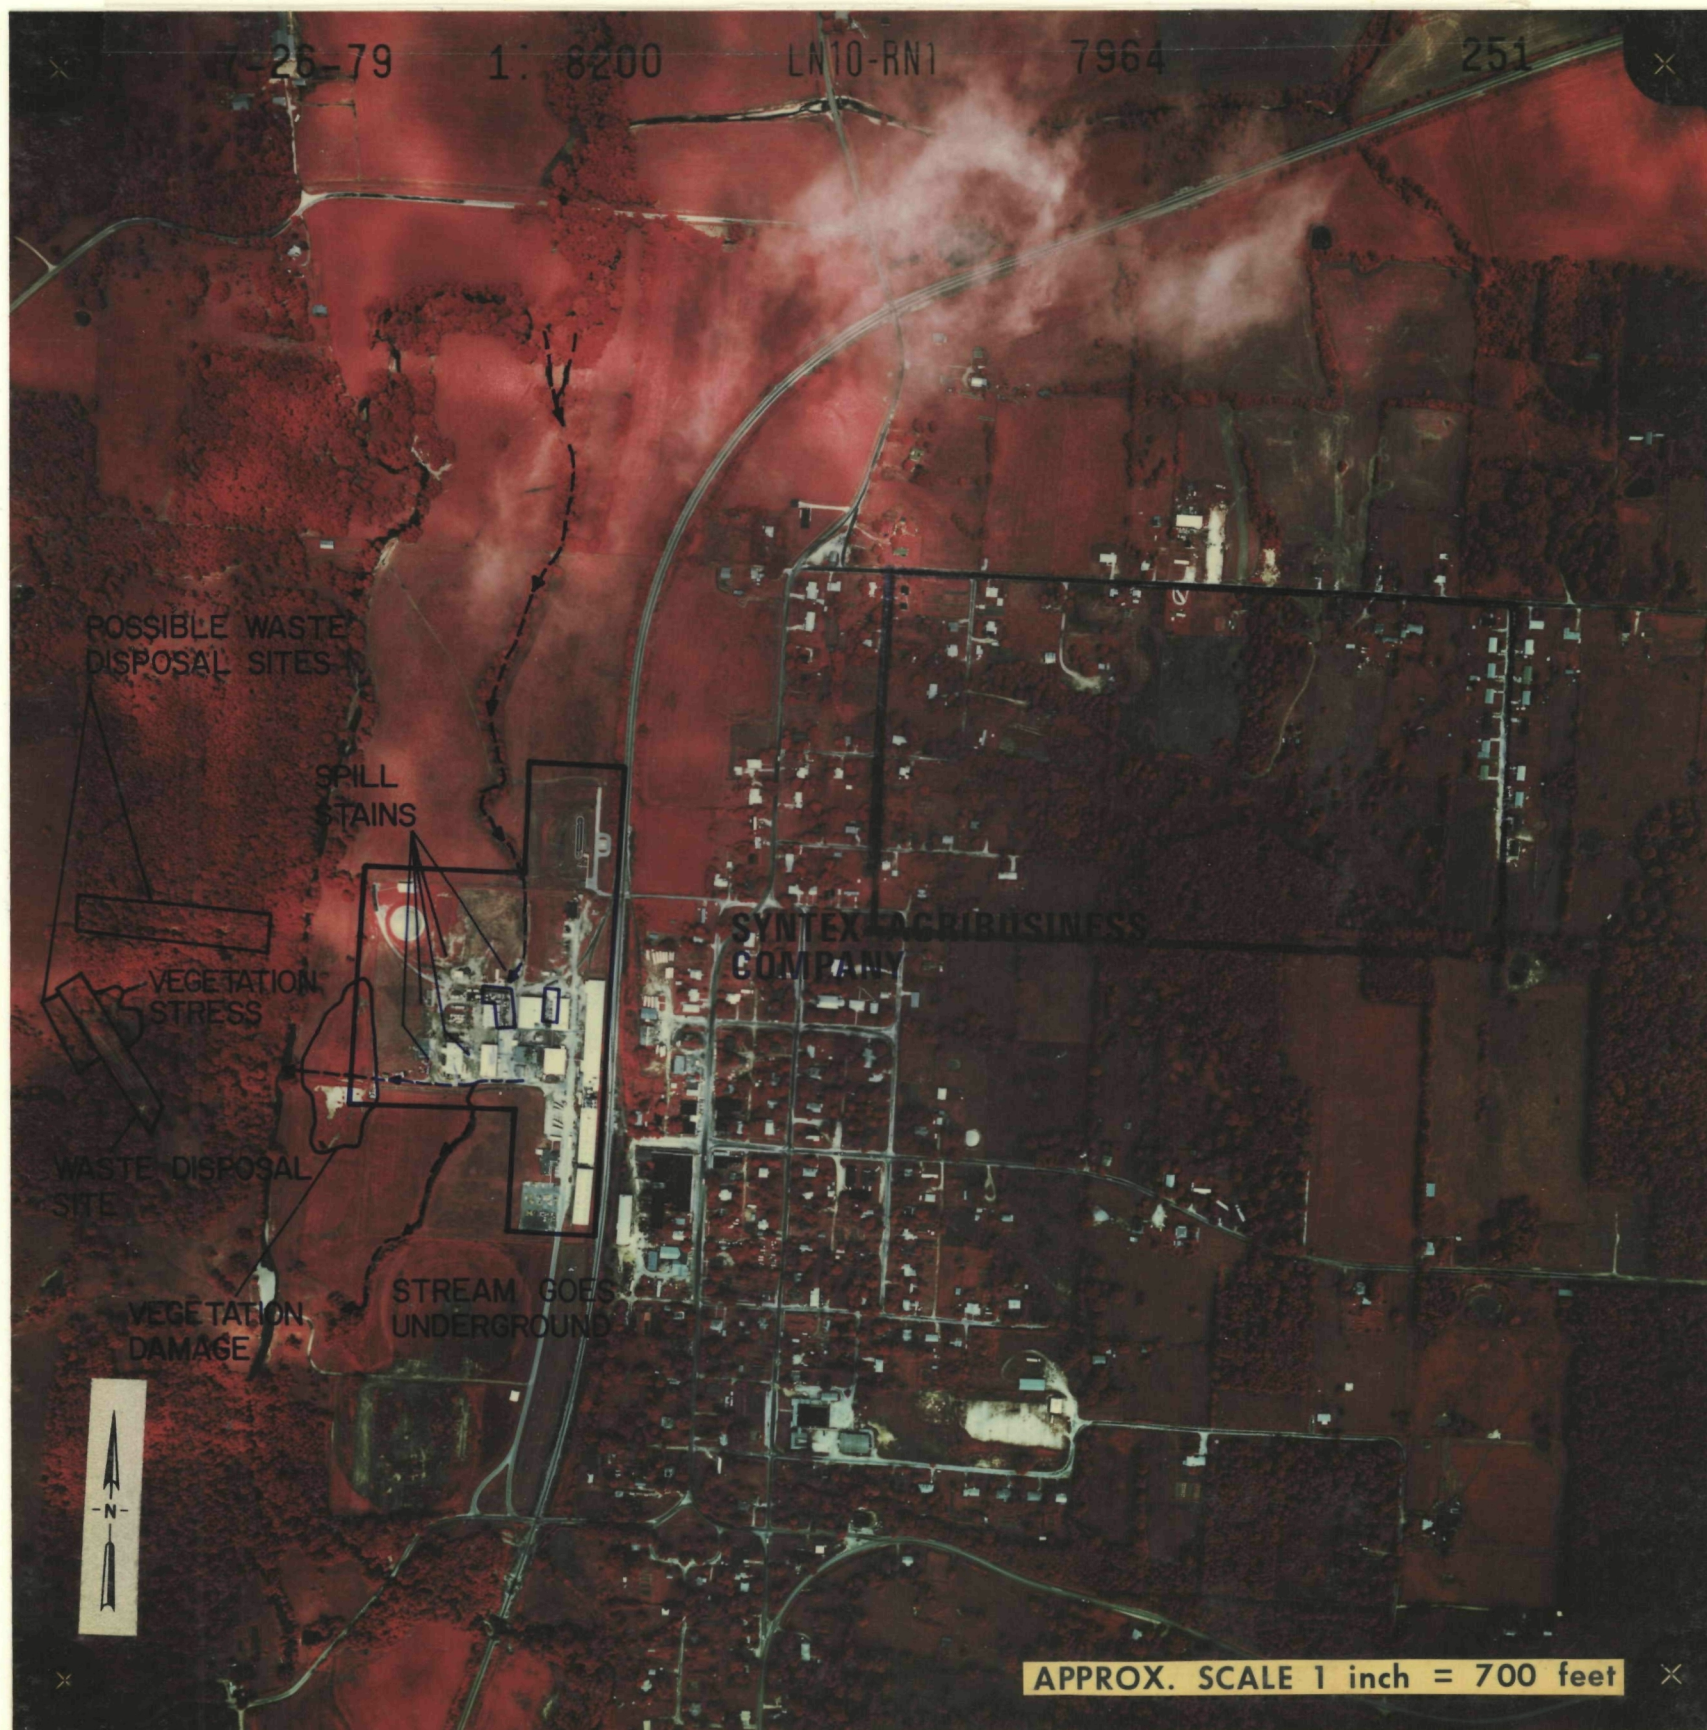
SYNTEX AGRIBUSINESS COMPANY (SITE 14)

This site is located along the St. Louis-San Francisco rail line just west of Verona, Missouri. The plant has 13 vertical and 2 horizontal processing tanks which lack secondary containment. Extensive spillage was evident throughout the facility and especially in the waste treatment areas. A branch of the Spring River flows into the plant area from the north, appears to go under the plant and exits to the south and west near the southern perimeter fence. The drainage to the west re-enters the Spring River directly and the southern drainage goes underground approximately 300 feet east of the river. Spillage was entering the branch stream in the waste treatment area in the northern part of the facility. The known waste disposal areas west of Spring River were inactive at the time of overflight. Vegetation stress was evident on the surface of two probable burial trenches in the main area and in the trees adjacent to the northeast end of the known burial site. Two other possible areas of disposal are annotated on page 73; however, tree cover precludes positive identification.
